NIST Special Publication 901

The January 17, 1995 Hyogoken-Nanbu (Kobe) Earthquake

*Performance of Structures, Lifelines, and Fire
Protection Systems*

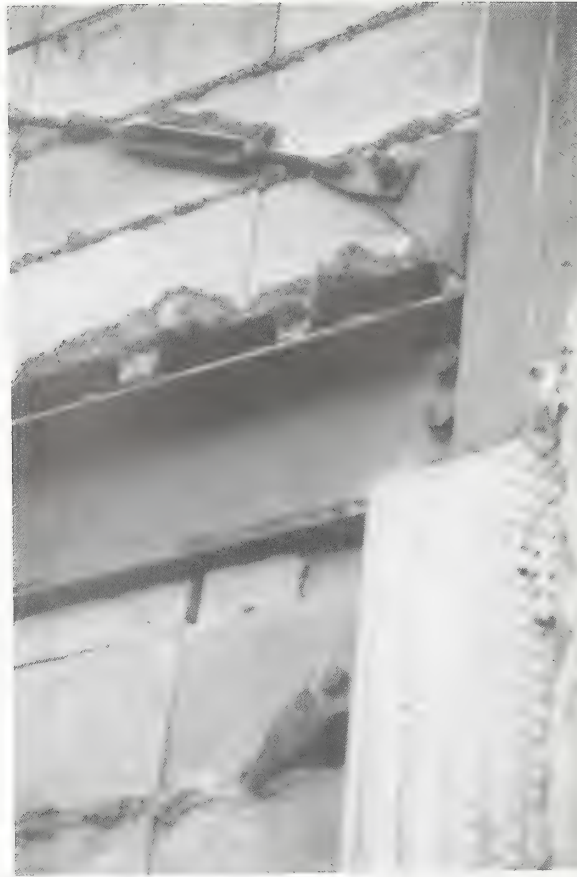
Figure 3.5.9 Many braced frame structures had failures of the diagonal braces at the welded connections. This photo shows a weld fracture between the turnbuckle rod and the gusset plate.

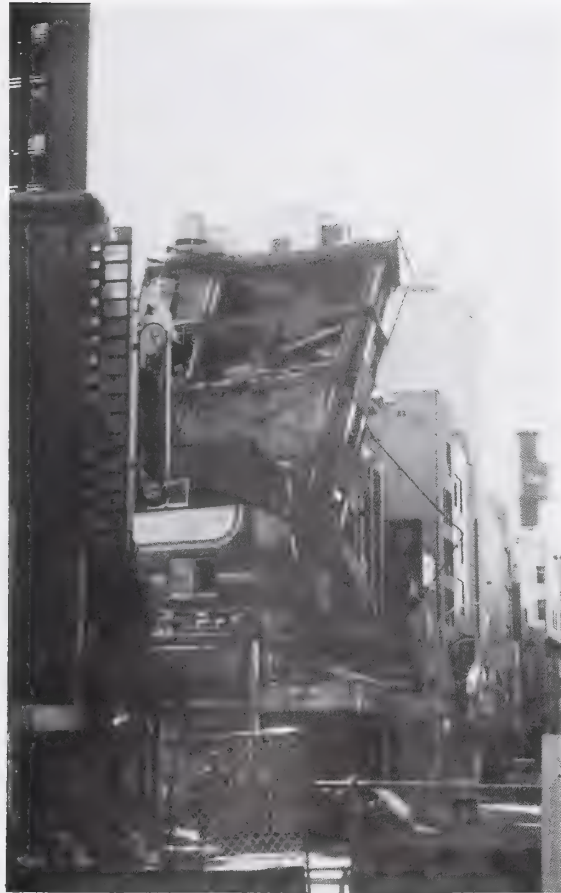
Those braced frame structures which did not have infilled walls were more flexible. One of the more striking failures in downtown Kobe was a seven-story braced frame system (Figure 3.5.10) with autoclaved lightweight concrete panels for cladding (Figure 3.5.11). This building had a very narrow platform with one bay in the east-west direction and two bays in the north-south direction. However, the building drifted severely toward north (stiffer direction) due to fracture of numerous braces (each approximately 6 mm x 75 mm in cross section) at bolted connections to gusset plates which are welded to the columns. In the upper floors, it can be seen that the braces in tension, which attempted to prevent displacement of the building toward the north, fractured through the bolt hole. The building remained standing only due to the presence of bolted shear connections for the beams, which managed to resist some lateral load.

Figure 3.5.10 Partial failure of a 7-story steel braced frame structure. Braces failed in tension at the bolted connections. Significant rust is evident in most closeups (see next four slides) around the vicinity of these bolt holes which may have permitted widespread fracture of the brace plates (approximately 6mm x 75mm plate).

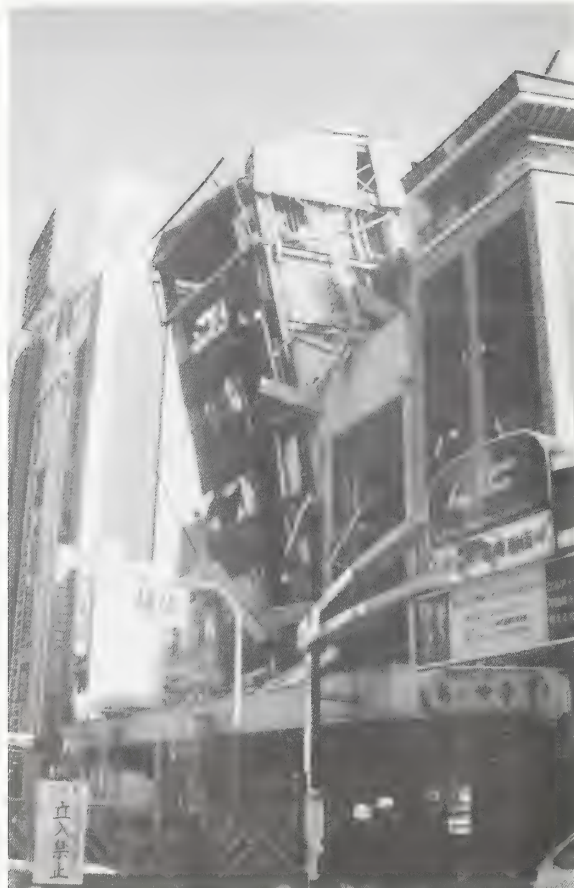
Figure 3.5.11 West side of the building shown in Figure 3.5.10.

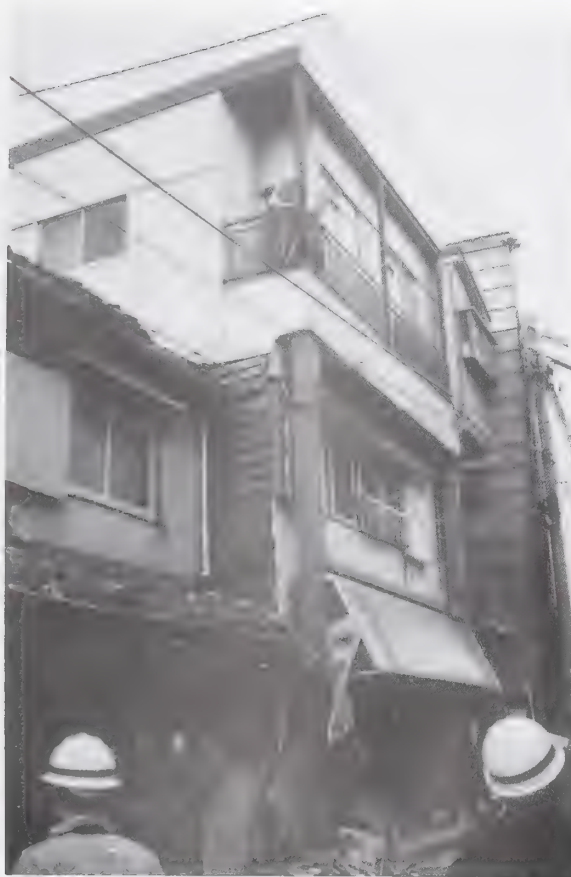
Figures 3.5.12 and 3.5.13 are of a rather unique braced frame failure in Higashi Nada ward. This was originally a two story Ohkabe type traditional dwelling, as evidenced by the exposed slat timber wall construction beneath the stucco in Figure 3.5.12. At some time a third story was added. To do this, an exterior steel braced frame was used. During the earthquake the cross braces (18 mm round bars) failed. These were attached to the steel frames apparently by means of field welded clip angles (Figure 3.5.14). The clip angle welds failed and the third floor shifted westward by approximately 300 mm.

Figure 3.5.12 Two-story traditional Ohkabe construction house with a third story add-on supported by a steel braced frame near the Mikage metro station, Nada ku.

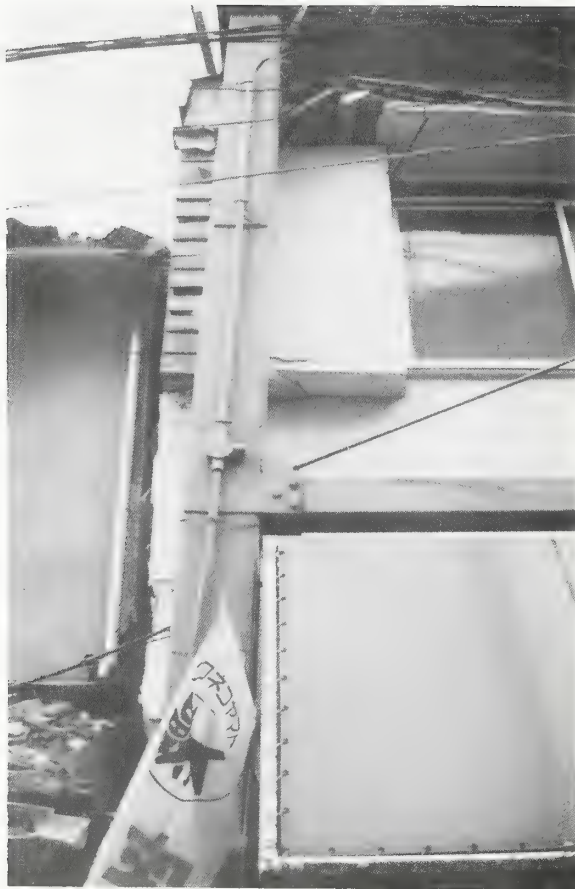
Figure 3.5.13 Detail showing drift in the building shown in Fig. 3.4.16 when diagonal braces failed.

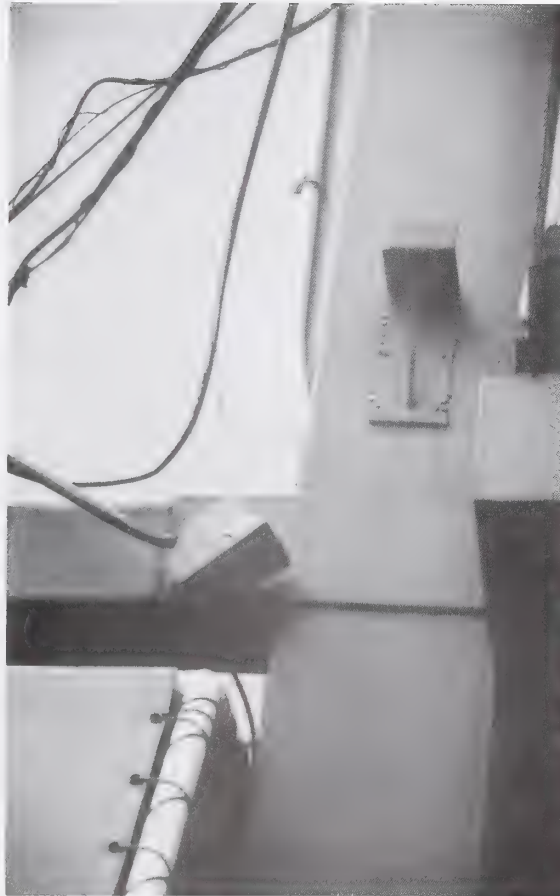
Figure 3.5.14 Detail of brace failure: angle plate weld to the steel frame failed (not the tension diagonal rod).

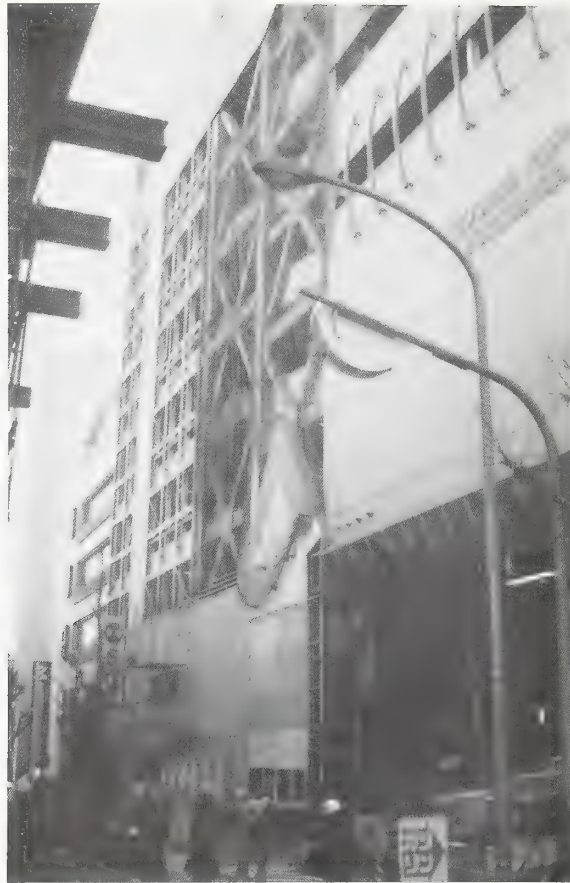
Column buckling in steel structures was a relatively rare event, with the notable exception of some unusual failures in transportation infrastructure. An example of column buckling in an 8-story building was a parking garage in downtown Kobe (Figure 3.5.15). This structure (NO.2 South Parking Building) is comprised of tubular columns (16 mm wall thickness) and wide-flange beams with diagonal braces. The first two floors of the northeast corner of the structure has a large unobstructed open space for the gas station. It was the northeast steel column that buckled (Figure 3.5.16). An unusual architecture (large eccentric open space on the first floor) contributed to the excessive loads experienced by column.

Figure 3.5.15 Northeast corner of a Mitsubishi/Sogo garage/gas station located just one block east of Kobe City Hall. Main steel tubular column at the northeast edge of the first floor opening buckled.

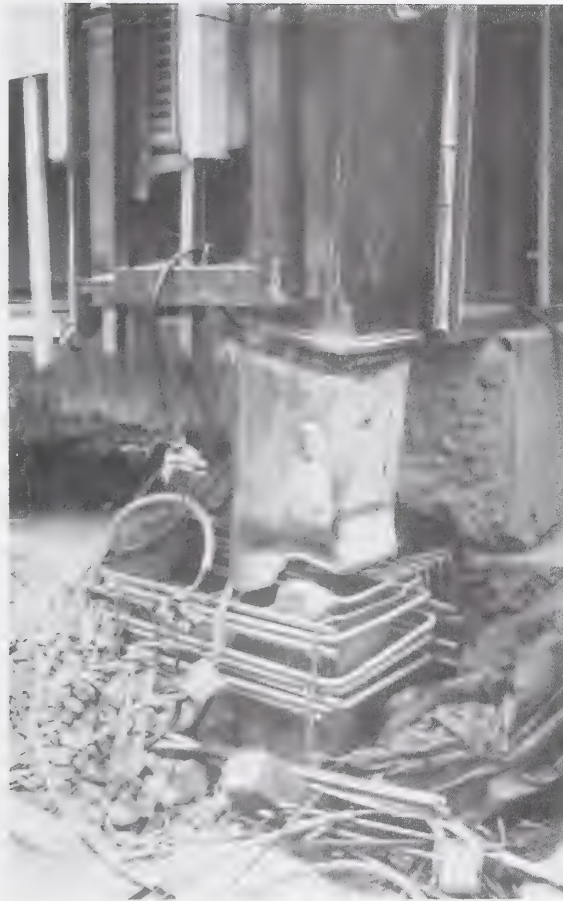
Figure 3.5.16 Closeup of the buckled tubular column in Figure 3.5.15.

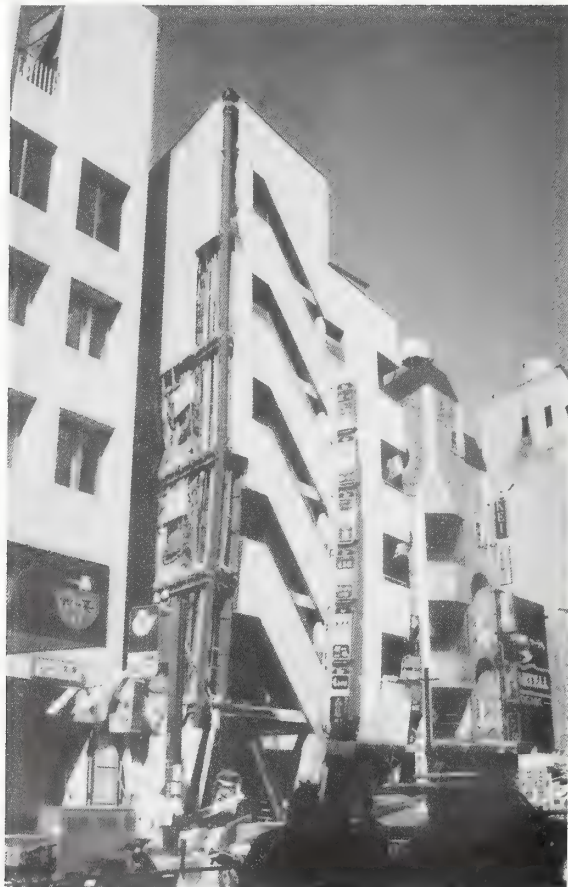
One example of moment frame structures which did suffer severe damage was a seven-story Nari Hiro Building in downtown Kobe (Figure 3.5.17). Figure 3.5.18 shows a closeup view of the southwest column, second story junction showing lateral buckling of the first story column. This, however, was a result of more dramatic weld failures on the east face of the building.

Figure 3.5.17 "Nairo Hiro" Building, a seven-story steel moment frame structure in downtown Kobe.

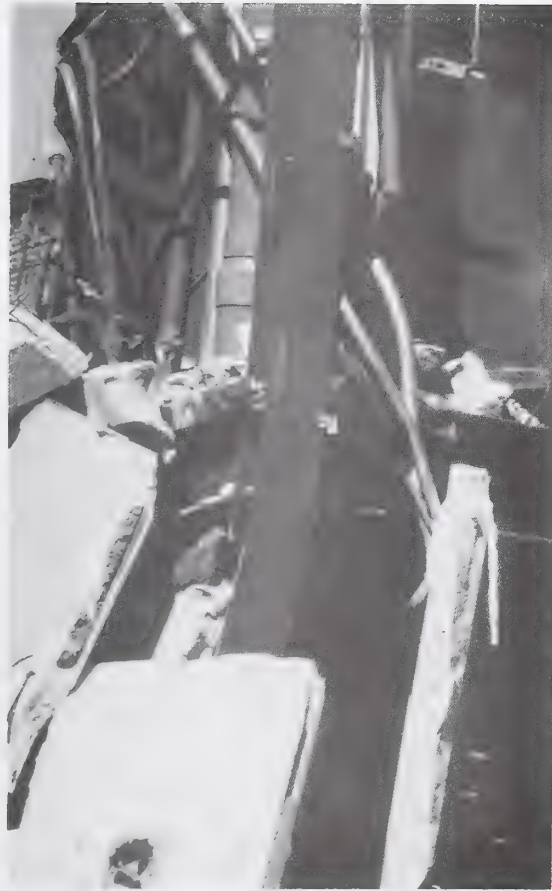
Figure 3.5.18 Closeup photo of the southwest column, second story junction in the Nairo Hiro building showing lateral buckling of the column.

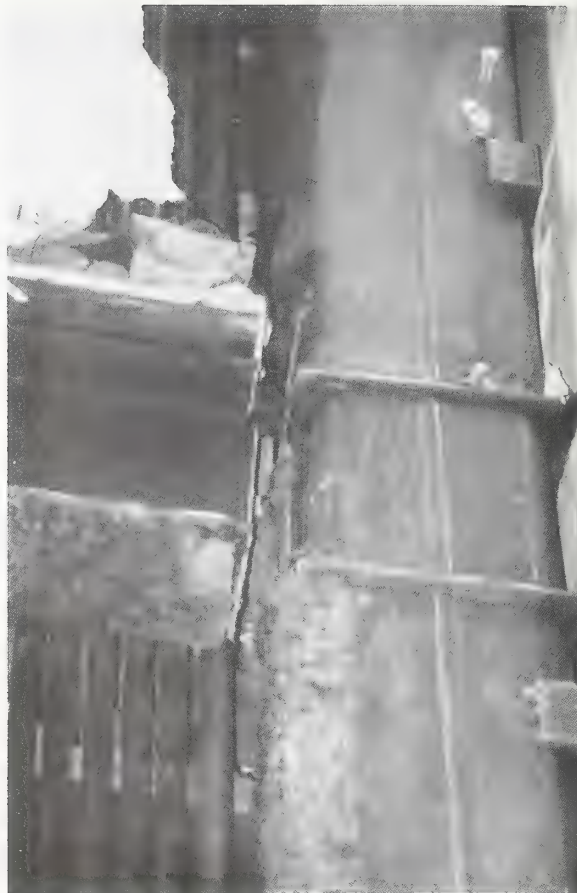
Figures 3.5.19 show details of a beam stub-to-column connection failure on the east face of the same building. Figures 3.5.20 and 3.5.21 show first floor column to second story column joint fillet weld failure.

Figure 3.5.19 Beam Stub-to-Column weld failure on the east face of the Nairo Hiro building.

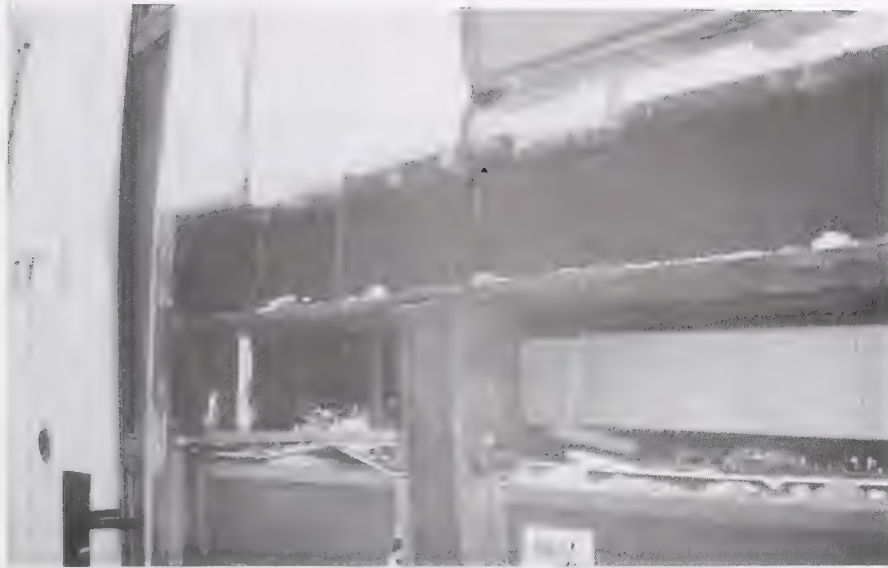
Figure 3.5.20 First floor column to second story column joint fillet weld failure on the east side of the Nairo Hiro Building, downtown Kobe.

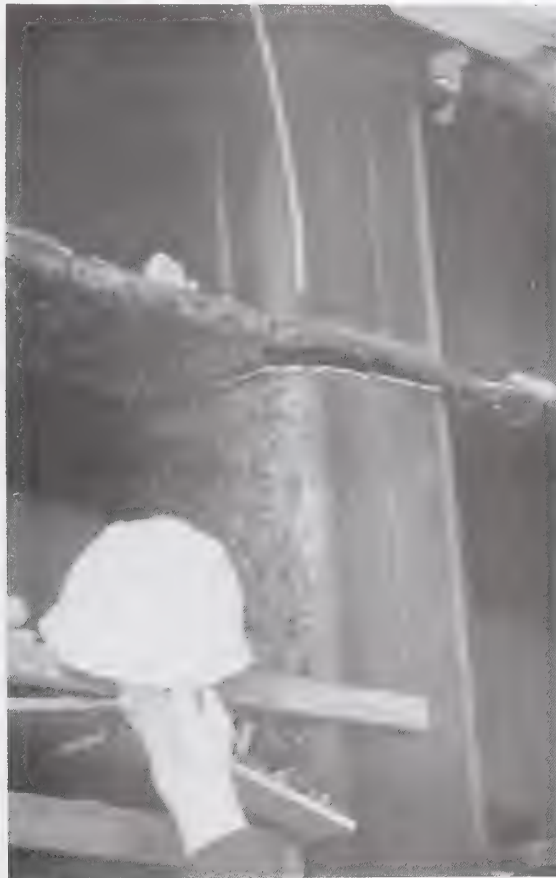
Figure 3.5.21 Closeup photo of column fillet weld failure in the Nairo Hiro building .

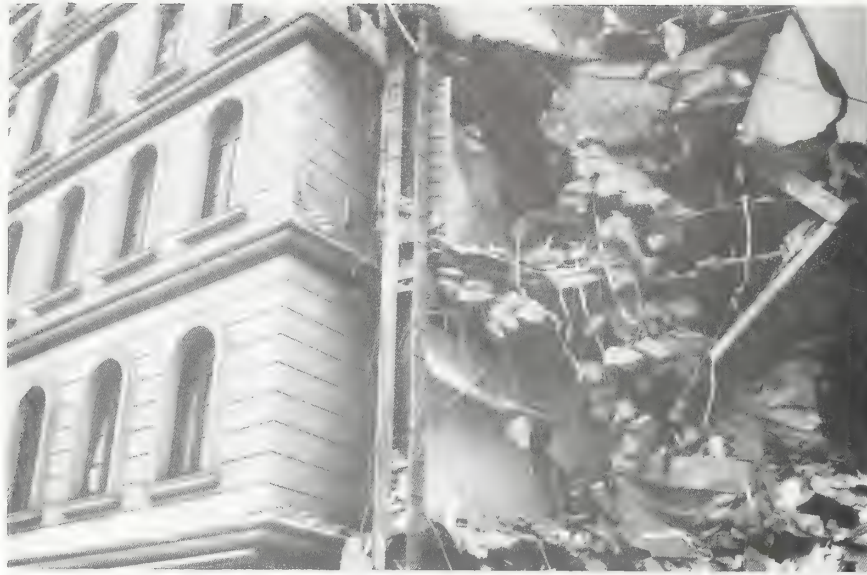
A 3-story steel frame building (Tanigawa Building) on Flower road in downtown Kobe also suffered beam-to-column connection failures (Figures 3.5.22 and 3.5.23). It is clearly seen that weld joint failure caused H-shaped girders to fall.

Figure 3.5.22 Collapse of the 3-story Tanigawa building on Flower Road in Kobe. This two-way steel frame was constructed of H-shape beams welded to columns.

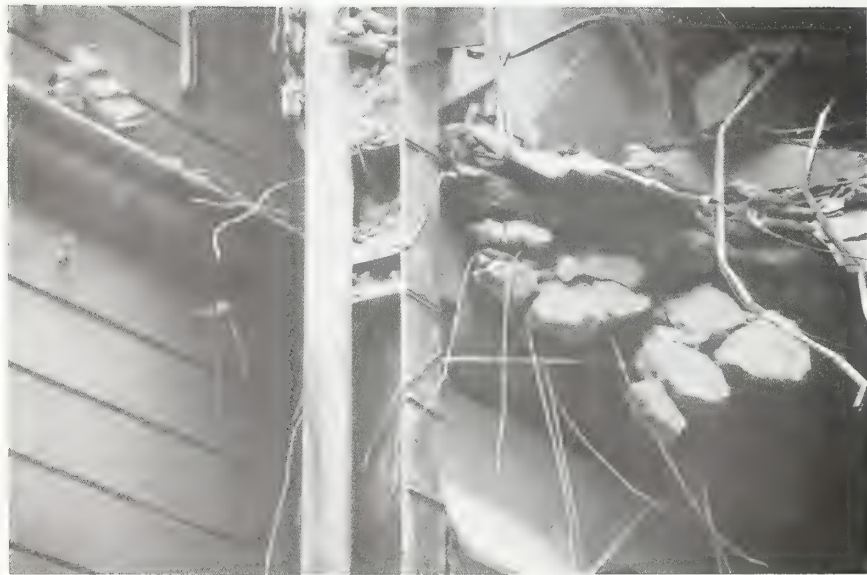
Figure 3.5.23 Close up of welded beam-column connection of Tanigawa building.

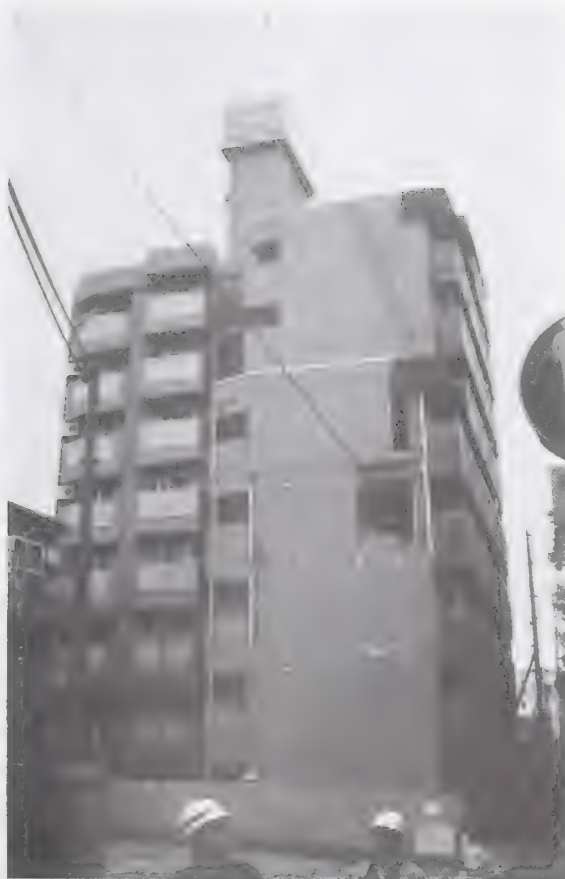
Figure 3.5.24 West face of the Liberty apartment complex in Higashi Nada-ku. This eight-story steel moment frame was typical of the performance of mid-rise steel structures designed according to post-1981 procedures.

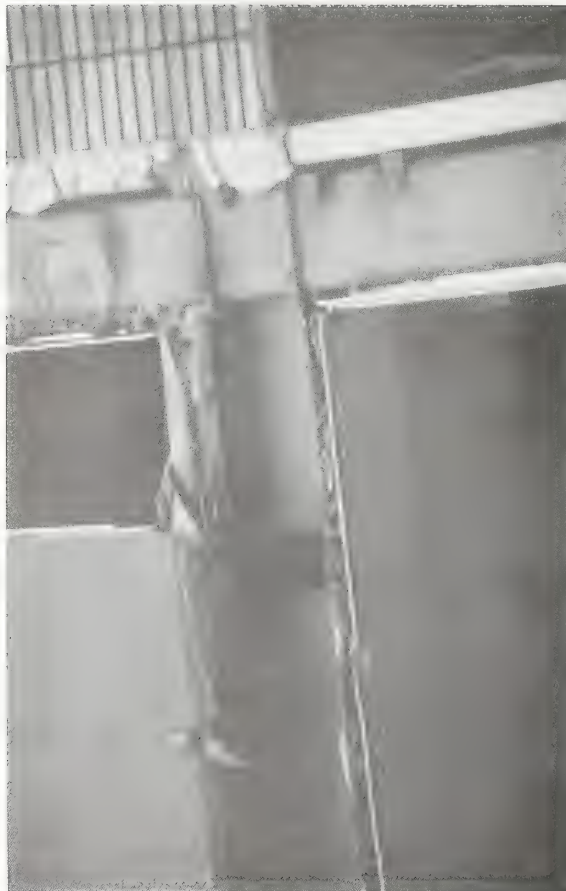
Figure 3.5.25 is a closeup view of west face steel moment frame of the Liberty apartments. The shop welded frame shows no damage but autoclaved lightweight concrete cladding suffered brittle failures along panel edges. Figures 3.5.26 and 3.5.27 show details of the east face of this same building. In this case one beam-column joint showed flaked paint indicative of local yielding.

Figure 3.5.25 Closeup photo of west face steel moment frame of the Liberty apartments. Shop welded frame shows no damage but autoclaved lightweight concrete cladding suffered brittle failures along panel edges.

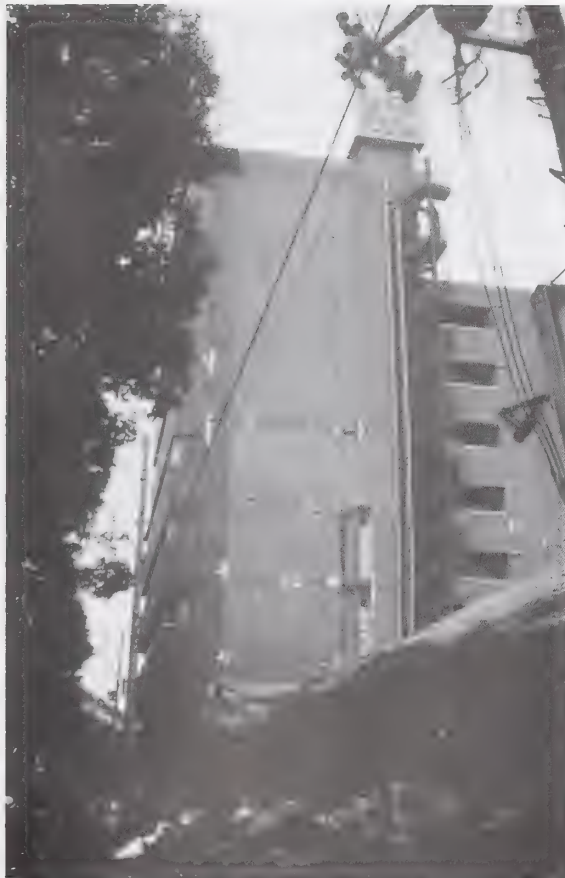
Figure 3.5.26 East face of the Liberty apartments.

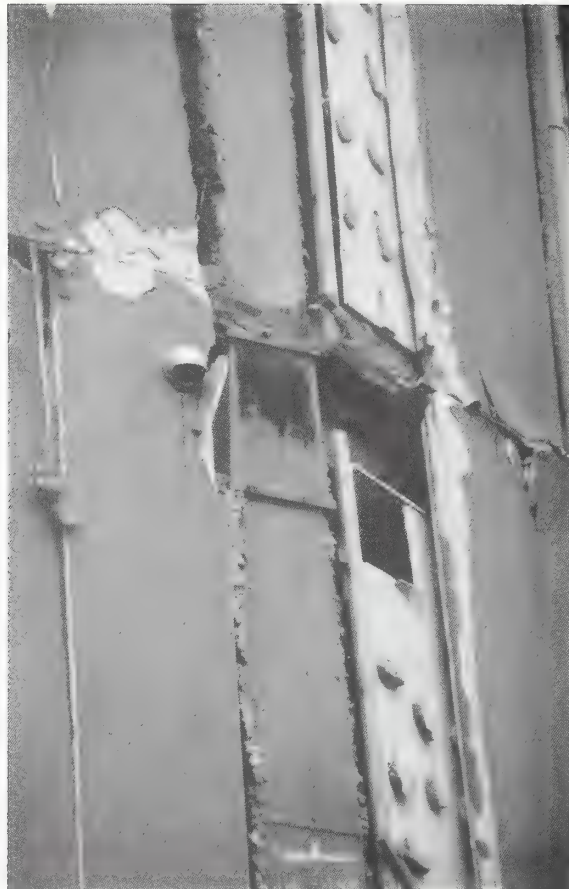
Figure 3.5.27 Closeup photo showing locally yielded third floor column joint in the Liberty apartment complex.

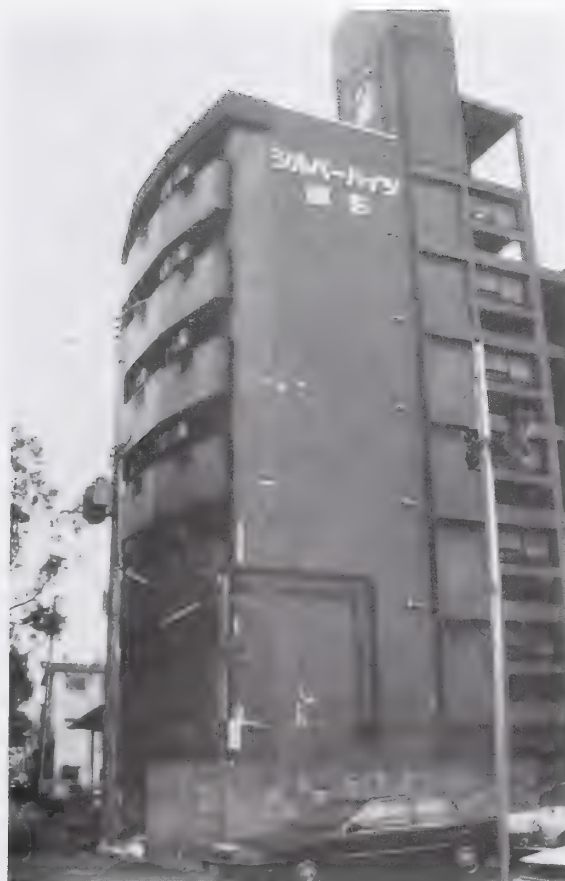
Figure 3.5.28 Seven-story Silver Heights Hotel in Higashi Nada-ku. This was another steel moment frame mid-rise building with cracking in the precast lightweight cladding.

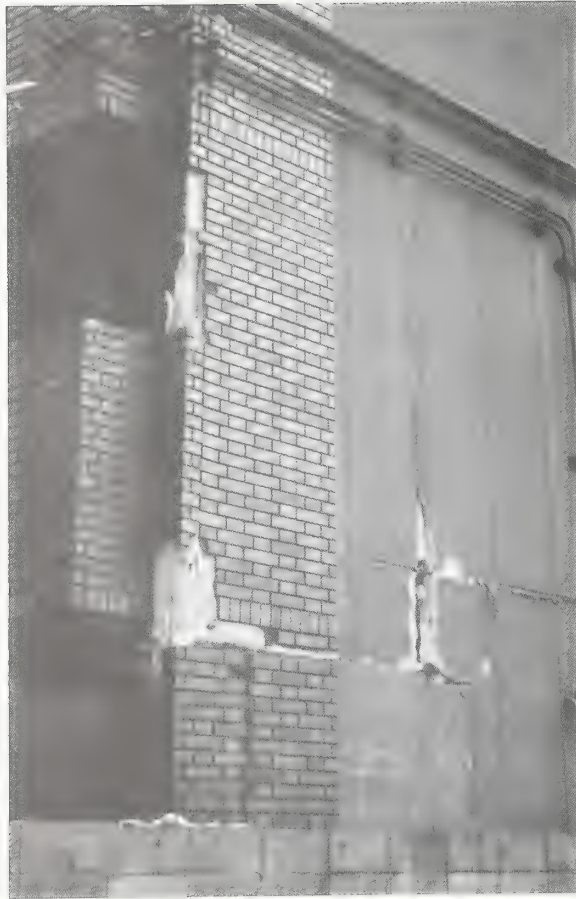
Figure 3.5.29 Closeup of cladding cracking at the Silver Heights Hotel.

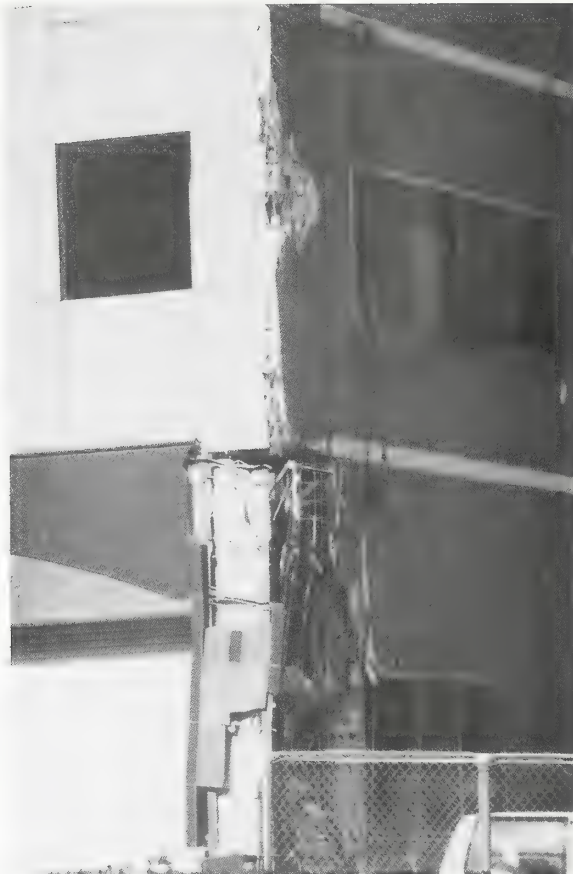
Figure 3.5.31 Detail of southeast corner of Pacific Power Corporation building.

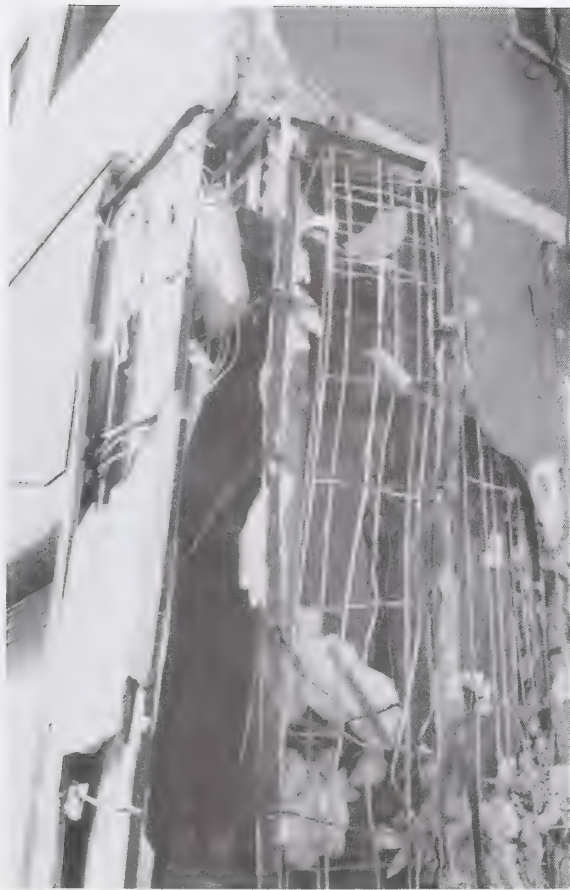
Figure 3.5.32 Closeup photo revealing steel moment frame beneath failed cladding of the Pacific Power Corporation building.

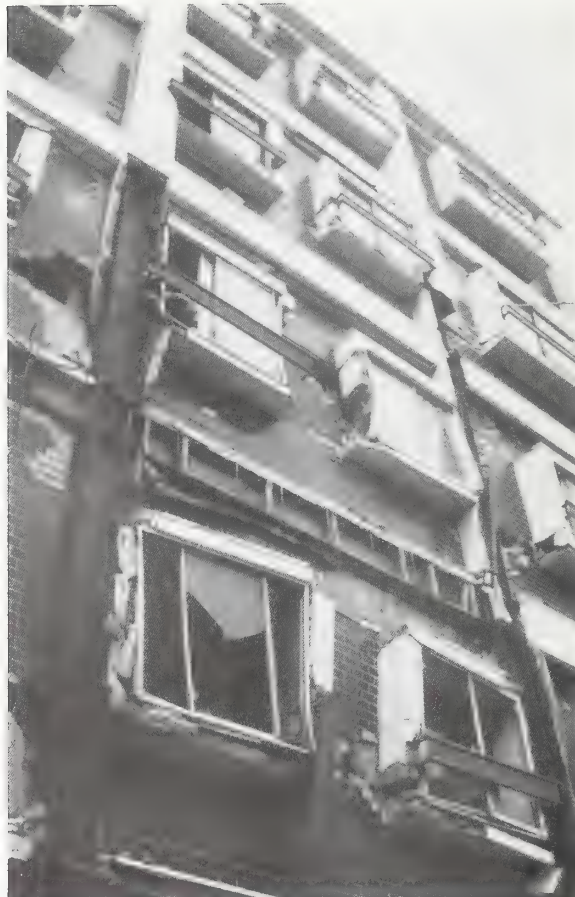
Figure 3.5.33 Older 5-story steel moment frame building showing extensive cladding damage to brittle cladding in Nada-ku near the Mikage metro station.

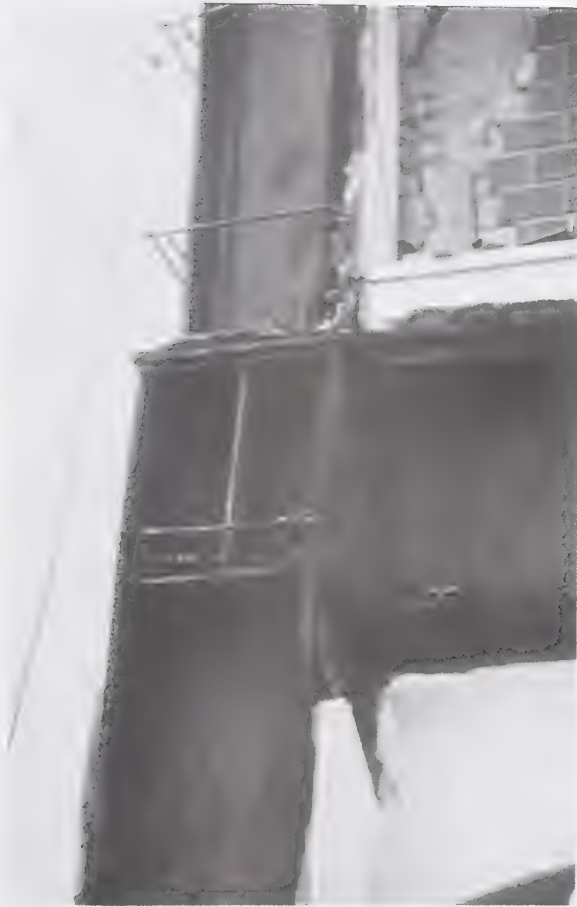
Figure 3.5.34 Closeup of rusted, older steel moment frame.

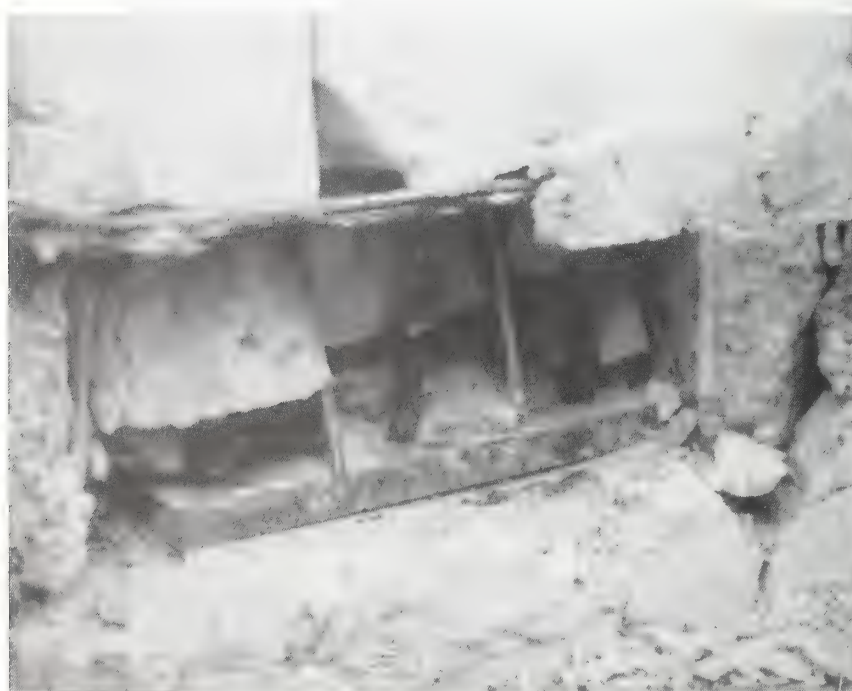
Figure 3.5.36 SAGA Building, anchor bolt was pulled out about 10 cm.

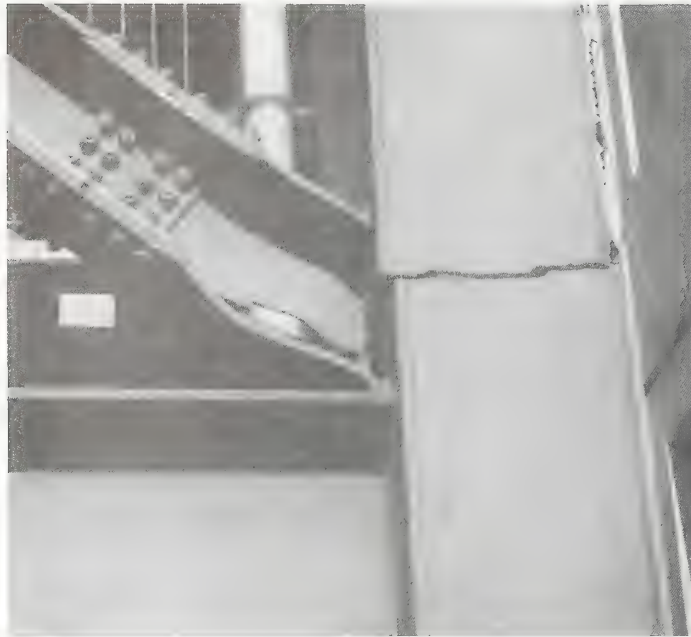
Figure 3.5.41 Complete fracture through a steel column section.

A final note concerning steel structures are the questions raised by the extensive base metal and weld failures observed at the Ashiya Hama Seaside Town (AHST) complex in Ashiya City. A number of thick column sections and diagonal bracing members sustained brittle failures. These failures echo problems first observed in steel structures in the United States following the Northridge earthquake.

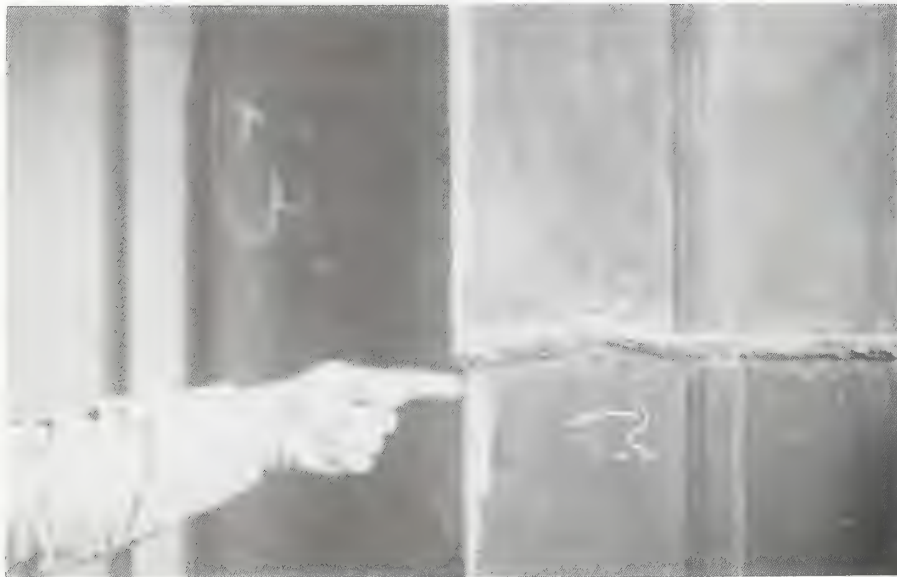
Figure 3.5.42 A repaired column immediately after the earthquake (Portland Cement Association).

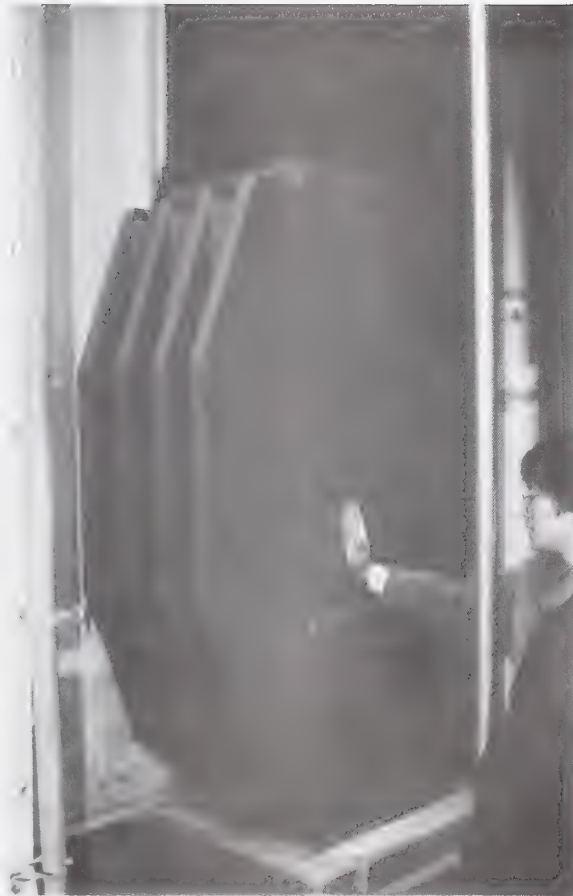
Figure 3.5.43 A column repaired not only with full-penetration weld, but also with stiffeners added.

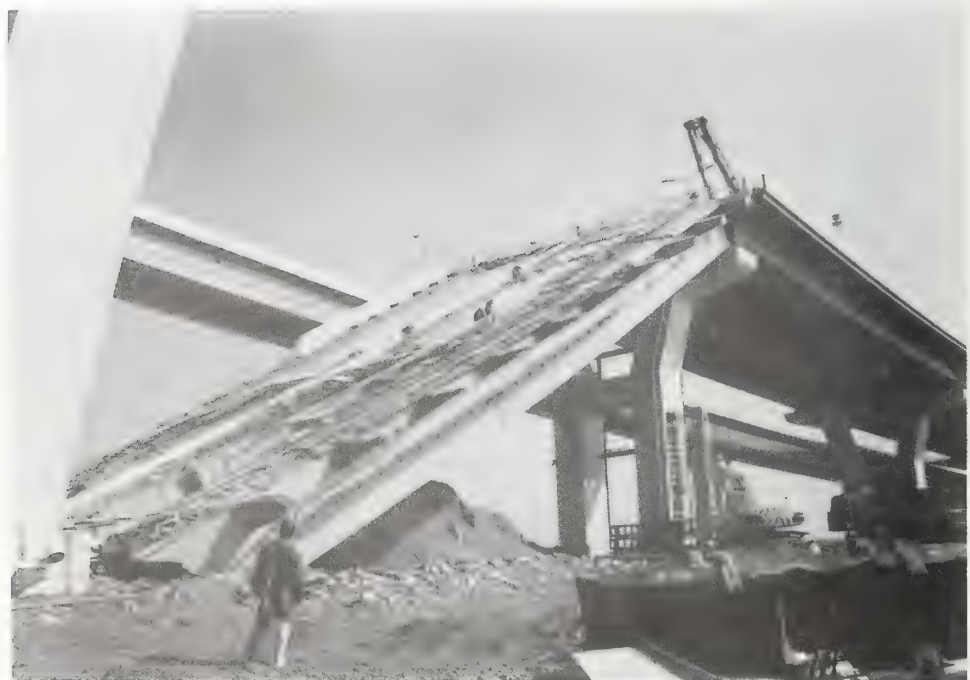
Figure 4.2.2b Collapsed approach span between Piers 111 and 112, Nishinomiya-ko Bridge.

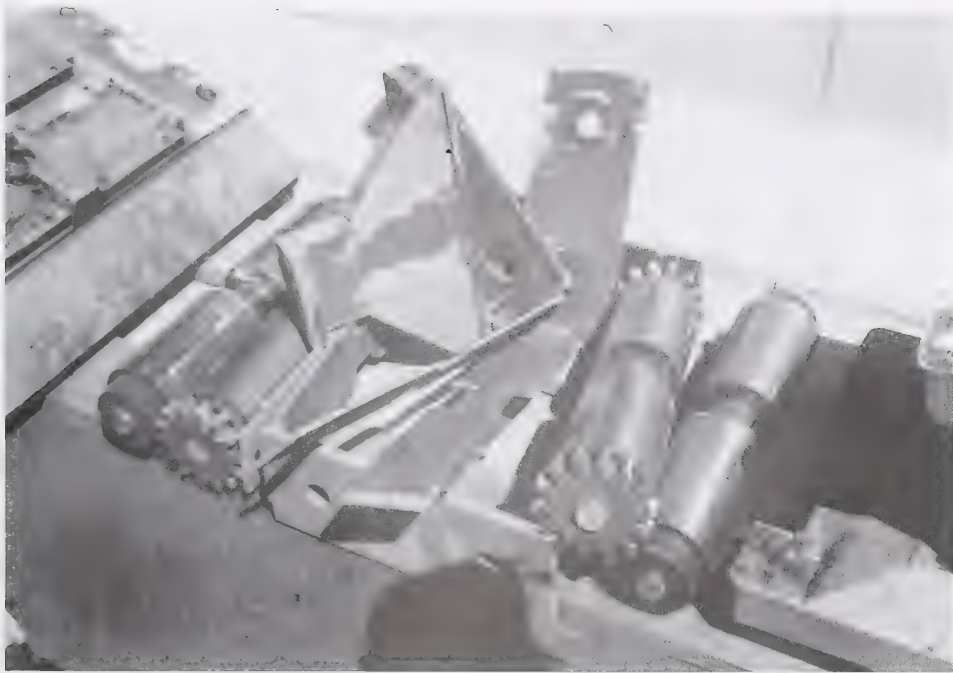
Figure 4.2.3 Damaged expansion bearings from under approach spans, Nishinomiya-ko Bridge, showing nested rollers and guide rails.

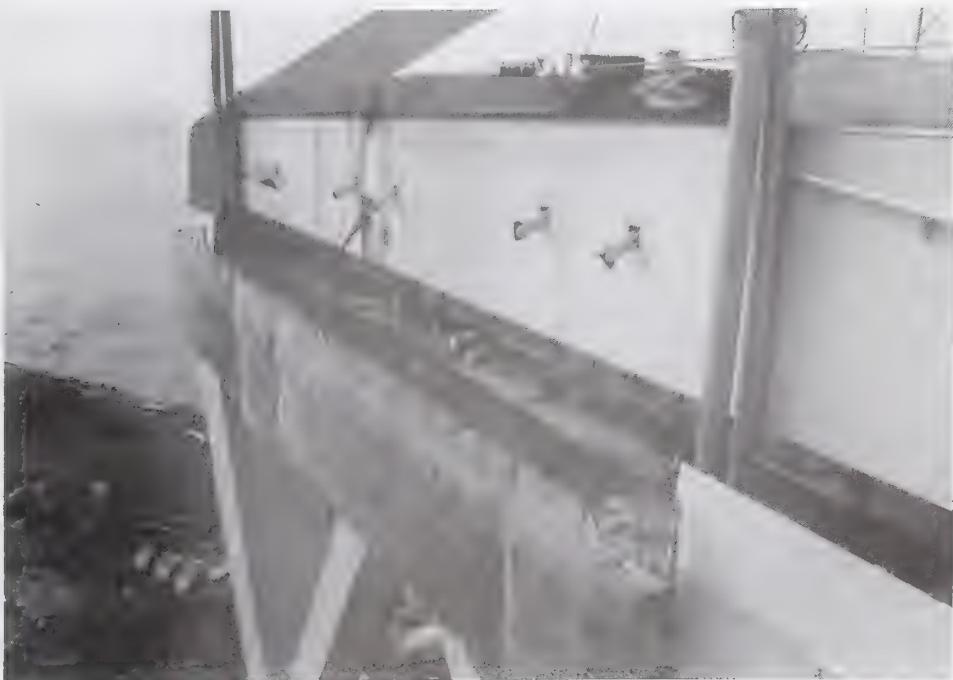
Figure 4.2.4 Cap beam of Pier 111, Nishinomiya-ko Bridge, showing cross-girder of arch and failed restrainers.

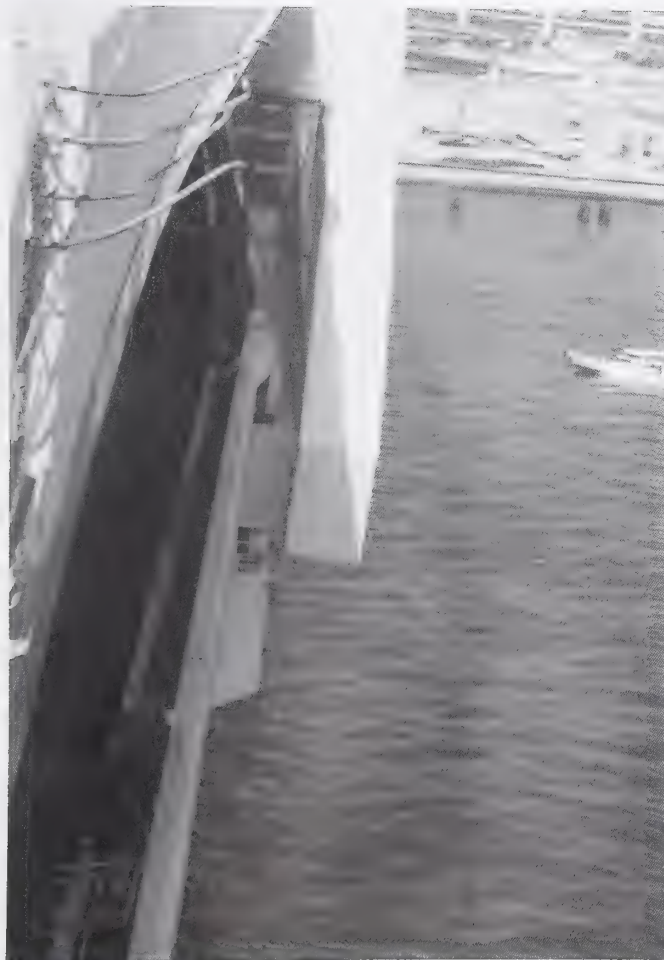
Figure 4.2.7 Lateral offset at east face of South Pier, Rokko Island Bridge.

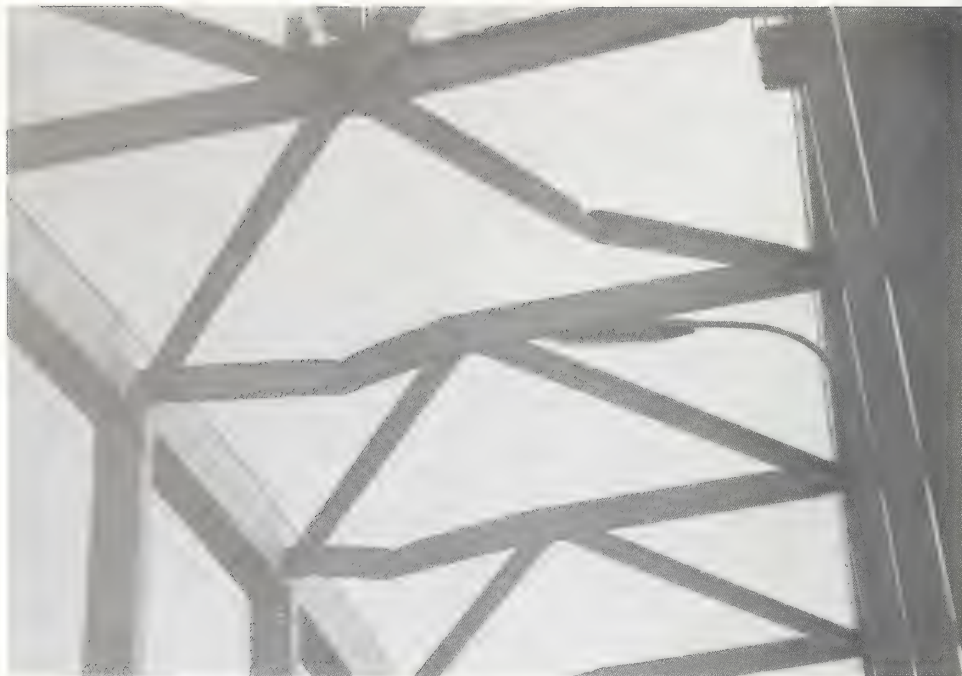
Figure 4.2.8 Buckled cross-members in Upper Chord, Rokko Island Bridge.

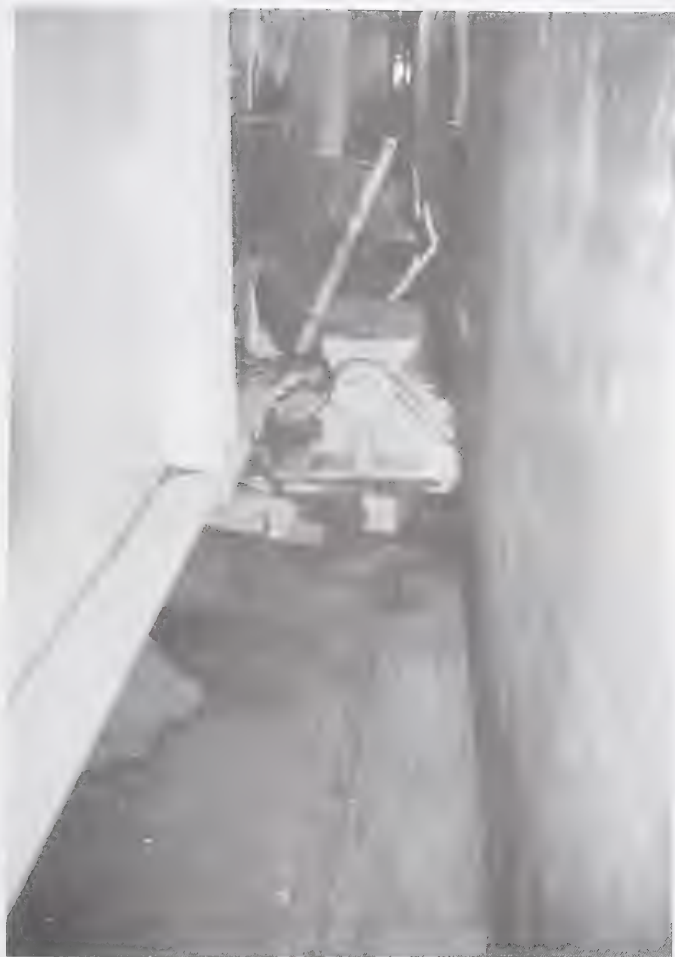
Figure 4.2.10 **Bearing and restrainer damage at abutment A1, Mukogawa Bridge,**
showing distorted guide rails and uncoupled restrainer from abutment
backwall.

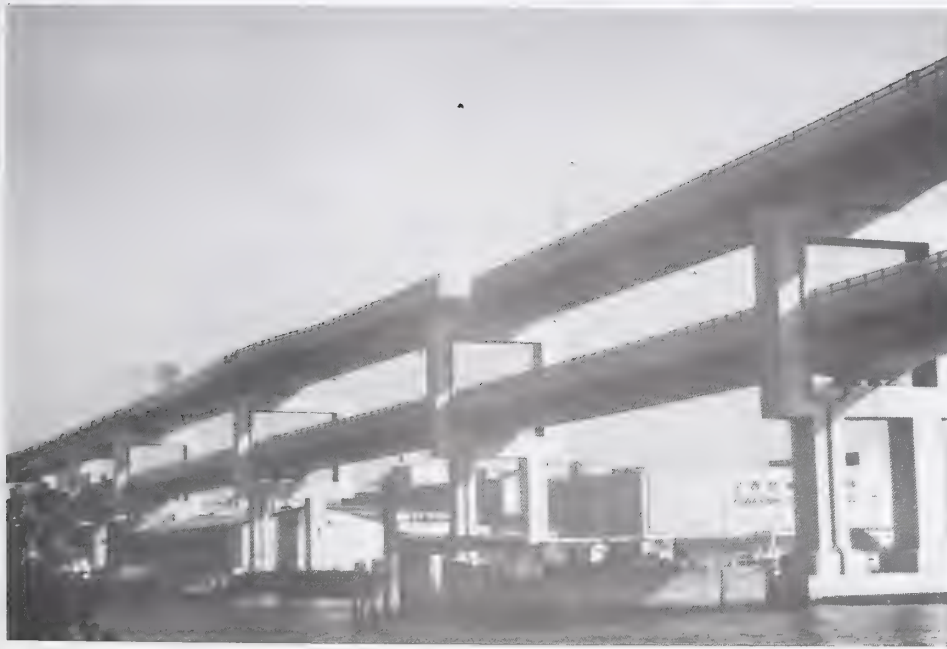
Figure 4.2.13 Lateral offset at Pier 36 in upper level of Hamate By-Pass due to bearing failures at Piers 34 through 38.

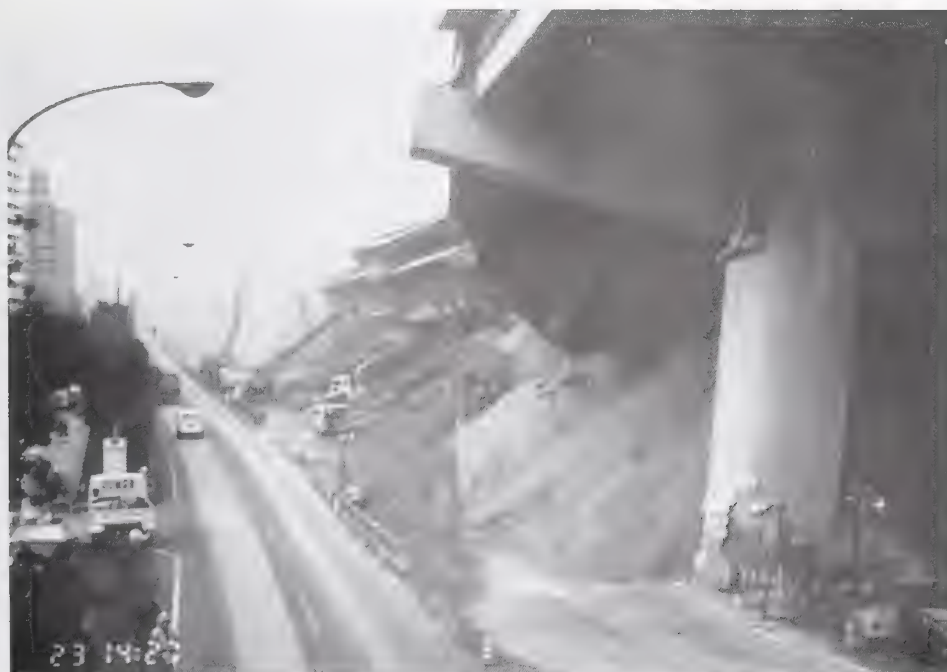
Figure 4.2.14 View of the collapsed Higashi-Nada Viaduct looking west from Pier 125.

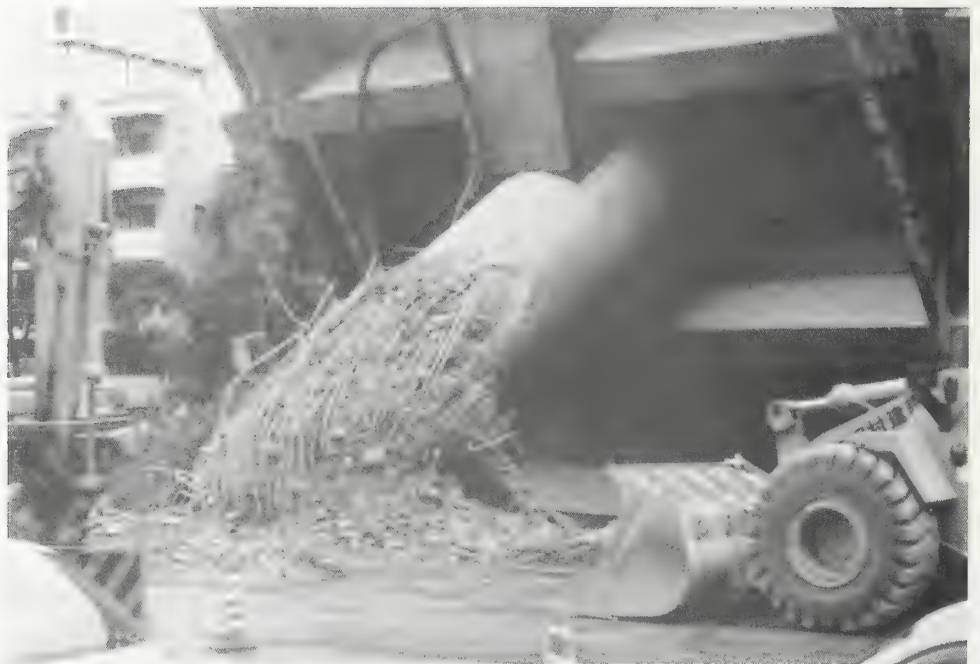
Figure 4.2.16 Higashi-Nada Viaduct, Pier 134.
